The Impact of Increased Traffic and Explosion Loads on the Concrete Bridges Baniwalid Bridge - Case Study

Abstract— The Baniwalid Bridge is located at the entrance of the city. This bridge was implemented during the seventies of the last century and was opened to traffic in the eighties. It is considered the main artery for traffic, linking the two sides of the city. Its length is about 500m, and its width is 20m. It has two directions; each direction is 8 meters wide. The construction system of the bridge consists of 31 average spans, each of which is 14.5 meters long, and each span consists of 18 pre-stressed beams, with a height of 0.72 meters and a width of 1.00 meters. Traffic increased within the city in previous years as a result of the closure of the coastal road, which led to a change in the movement of freight and land transport to eastern and southern Libya through the cities of Baniwalid and Gharyan, where the bridge was subjected to very high traffic loads that far exceed the design loads. In this study, the bridge was inspected, some previous reports were reviewed, and the construction status of the bridge was determined in general. There are many cracks in the bridg

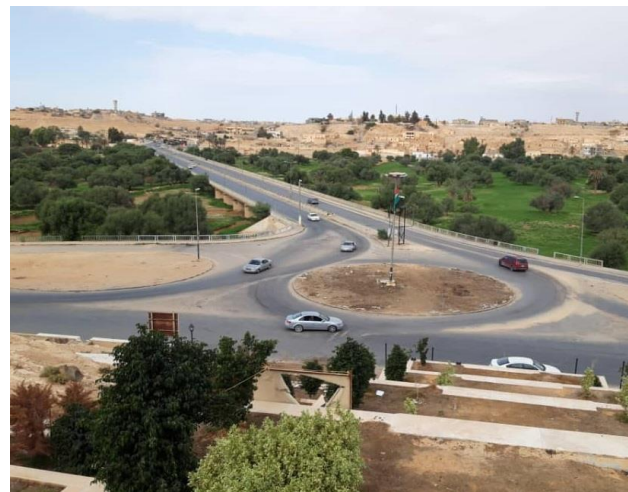
Figure 4. Baniwalid Bridge

As previously reported, the bridge is the vital artery of the city of Baniwalid, and as shown in figure 4, it is the only entrance to and from the city to the south and east of Libya. The traffic within the city has increased in last

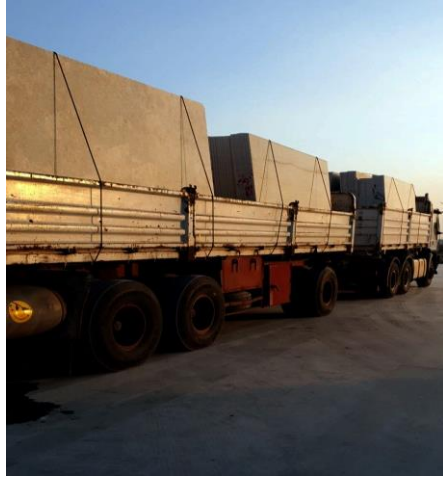
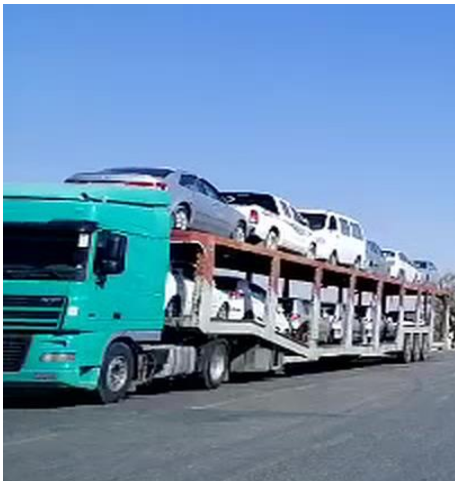
years because the coastal road has been closed. The freight and road traffic for eastern and southern of Libya through has changed to the cities of Baniwalid and Garyan, where the bridge has been being subjected to very high traffic loads that exceed the design loads, where in some marble trucks it has reached approximately 60 tons [8]. This has been detrimental to the appearance of many fractures, cracks and construction problems, as shown in figure 5 and figure 6

Figure 5. Traffic load

Figure 6. Traffic load

1. Adjust traffic and traffic weights as a first step in the bridge straightening and maintenance process.
2. Do more examinations and laboratory tests to determine the exact structural position.
3. Rapid maintenance of rainwater drainage holes.
4. Rapid maintenance of expansion joints.
5. Re-backfilling the foundations and implementing a stone tamping to reduce the drift process.
6. Treating cracks and rust on reinforcement steel.

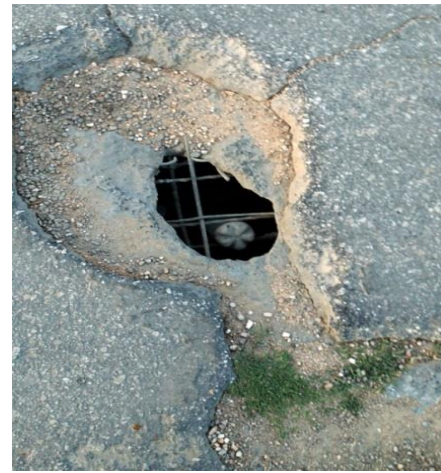
It has been observed that there are many problems, where longitudinal cracks parallel to traffic, occasional and crocodiles cracks are spreading, and some parts of the road above the bridge are swollen. There is also some damage because of explosions and shells, as shown in figure 7 and figure 8.

Figure 8. Explosion holes

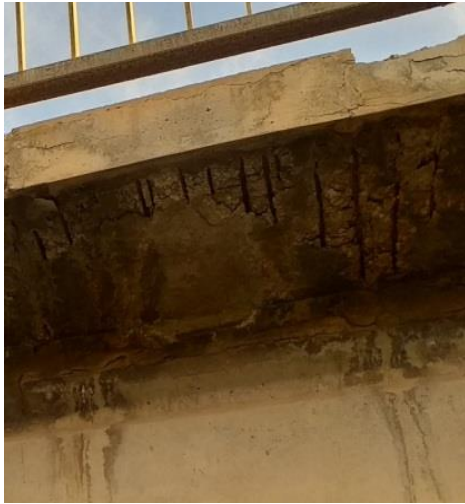
As shown in figure 9, 10. The metal cables of the box beams suffer greatly from rust, and there are breaks in some metal cables, in addition to the corrosion of the end of some of the beams. There are also longitudinal cracks parallel to the reinforcing wires in most of the beams due to high traffic stresses and water leakage from the top of the bridge because of the damage of the expansion joints and blockage of rainwater drainage holes.

Some of the beams were disintegrated due to explosions and direct exposure to missiles, which led to the occurrence of gaps and stripping of rebar and exposure to weather factors, which led to its corrosion and exposure to rust and thus cracks in the concrete cover.

Figure 9. Reinforcement steel rust

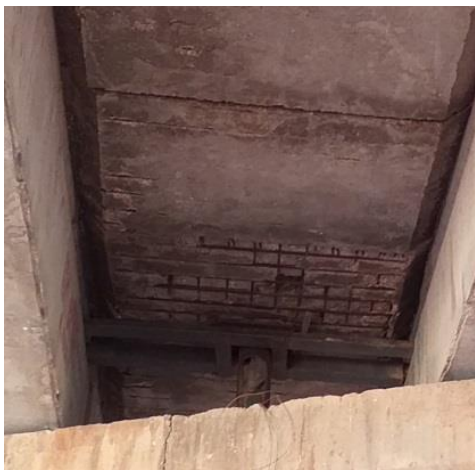
Figure 10. Collapse of concrete cover

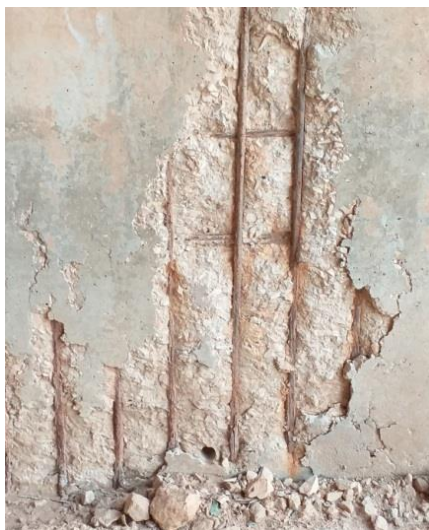
The cracks are widely spread due to the same reasons mentioned above, in addition to the impact of the piles in high temperatures due to the dumping of garbage and the setting fire next to them as shown in figures 11, 12.

Figure 10. Bridge Pillars.

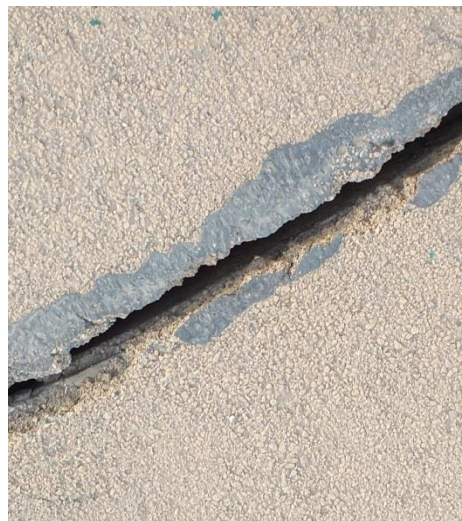
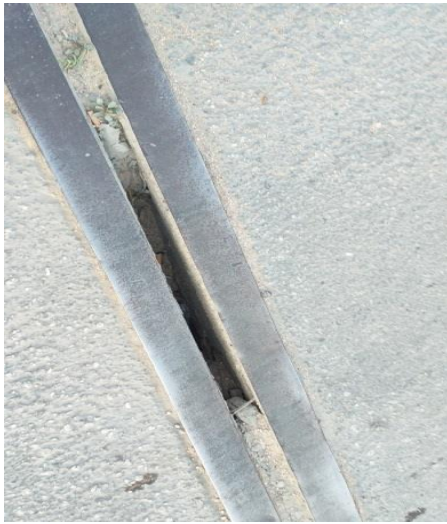
All bridge expansion joints suffer partial or complete damage due to long service life and lack of renewal and maintenance; It is currently filled with dust and dirt and causes rainwater to leak into the concrete bridge body and as shown in figures 12, 13.

Figure 12: Expansion joints.

Figure 13. Expansion joints.

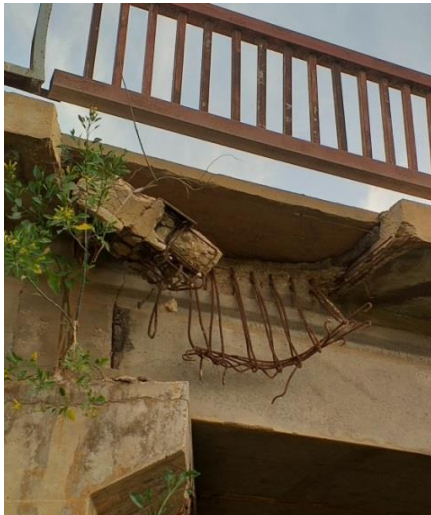
Figure (14) shows that the Sidewalks and pedestrian paths suffer from the same reasons mentioned above, where some sidewalks were exposed to rocket and missile explosions, weather erosion and rain water accumulation.

Figure 14. Sidewalk explosion.

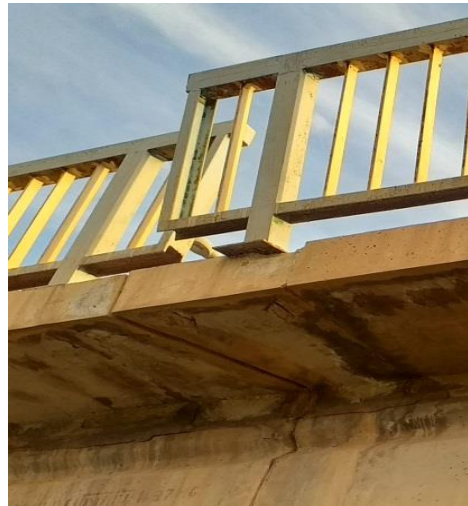
There are many deformations, collapses and corrosion in the iron fence body for various reasons, including traffic accidents, missiles, acts of sabotage and theft, as shown in figures 15, 16.

Figure 15. Iron fence slope.

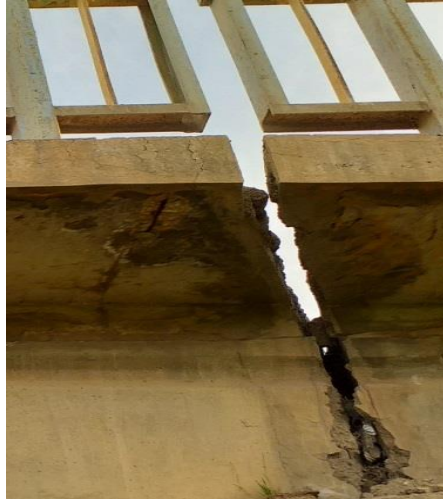
There is obvious horizontal creep in the approach slab at the south end of the bridge; it can be seen in figure 17.

Figure 17. Horizontal crawling of the approach slab.
