# Influence of GFRP Confinement of Reinforced Concrete Columns Exposed to Sodium Chloride on Microstructure and Hydration Products

**Abstract**— This paper explores the effect of sodium chloride (NaCl) on microstructure and hydration products of cylindrical column concrete and compares the results after covering it with Glass Fiber Reinforced Polymer (GFRP). 20 short RC columns were prepared with a single concrete mixture. The specimens have cured in different concentration of NaCl (0, 5%, 10%, 15%), some specimens cured directly in solution and other specimens exposed to wet and dry cycle. These specimens were tested, a first group after 28 days of curing, second group after 56 days, while the third group was repaired by GFRP after 28 day then returned to the cured environment and tested after 56 day. In order to determine the main crystalline phase composition of concrete specimens and for phase identification of a crystalline material, scanning electron microscopy (SEM) morphology of microstructure concrete and X-ray diffraction (XRD) have been used. The results revealed denser microstructure with the concentration of NaCl crystalline, existence of binding chloride as free hali

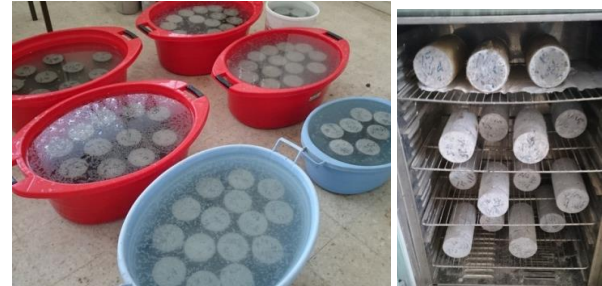
Figure 3. Curing condition a) in solution (0,5,10,15% NaCl; b) in oven of 60°C.

sodium chloride with different concentrations (5, 10, 15) %, where 3 samples are treated in each concentration, in addition to subjecting these samples to wet and dry cycle, one day in the solution and two days in oven drying at a temperature of 60°C, which is gradually raised and lowered. Curing condition details in solution with different concentration of NaCl are shown in the following “Figure. 3,”.

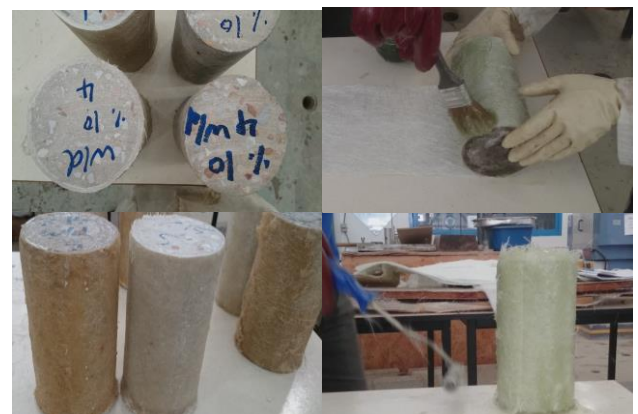
Figure 4. Covered column with GFRP.

After 28 days have passed since the samples were exposed to different damage conditions, one sample from each group is taken out and dried superficially from the solution. It is repaired by three layers of glass fibers and polymer GFRP as shown in “Figure. 3,”. The first step prior to GFRP application was cleaning the concrete surface. Then a primer of resin was applied to the surface of the column to ensure the adhesion of the fiberglass fabric to the column. The glass fiber fabric was then placed on the resin around the column, and the resin was applied through the glass fiber fabric, where three layers of the fabric were placed on the column, and the resin was placed between each layer and the other. A roller was used to ensure that the layers were adhered to each other, forming a single fabric around the column, in addition to making sure that there weren't air bubbles between the fabric layers. and kept until it dries completely for two days and then returned to the damage environment in which it was present, until tested after another 28 day.

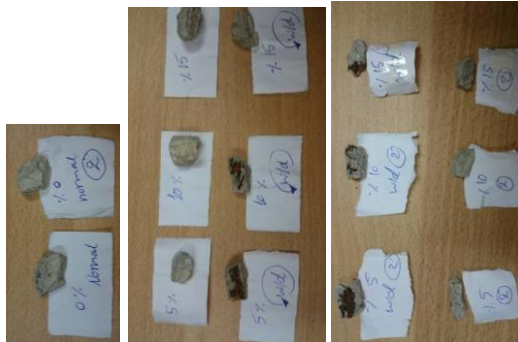
Figure 5. SEM samples.

Scanning electron microscopy (SEM) analyses of concrete specimens were carried out at Tunisian national oil company (ETAP), Tunis. Samples of pieces of concrete are prepared by taking 1 cm<sup>3</sup> from the concrete cover of a reinforced concrete column that were completely dry, pictures were taken at the concrete surface that contact with the rebar. Shown in “Figure. 5,”.

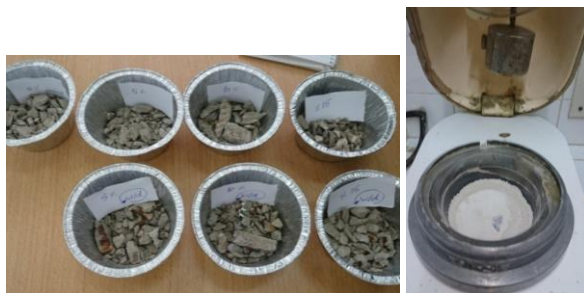
Figure 6. XRD samples.

The X-ray diffraction (XRD) analyses of concrete specimens were carried out at Department of Geology, College of science, University of Tunis El Manar, Tunis. The XRD analysis was done on the powdered concrete pastes that were prepared by taking them from the completely dry concrete cover of a reinforced concrete column, were crushing and grinding to a very fine powder using the described pulverizer “Figure. 6,” shown that,. The XRD analysis was performed for diffraction angle 2θ ranged between 5° and 70°.
