# Case Study of Stress Corrosion Cracking (SCC) on Natural Gas Pipeline and Types of Repairs

**Abstract**—Oil and gas pipelines are prone to various deficiencies, including stress corrosion cracking (SCC). This case study explores the methods and best practices for repairing a 34-inch distribution network of gas transmission and supply pipelines that serve various consumers along the Libyan coastline. It also highlights the vital importance of this facility in powering key industries, such as power plants, steel mills, and cement factories. The focus is on preventing and addressing SCC, including the use of split sleeving, repair clamps, and non-destructive testing (NDT) techniques.

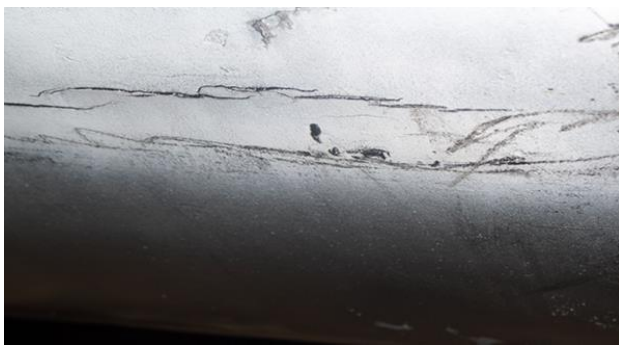
Figure 3: External Axial Stress Corrosion Cracking, determined by Rosen Smart Pig [1] [2]

Pipe sleeves are used for non-leaking defects such as pitting corrosion and stress corrosion cracking. These sleeves are fabricated according to API RP 1107 and ASME PCC-2–2008 standards. They are installed at a pressure below the failure threshold and welded onto the pipeline for a permanent repair [1], [2].

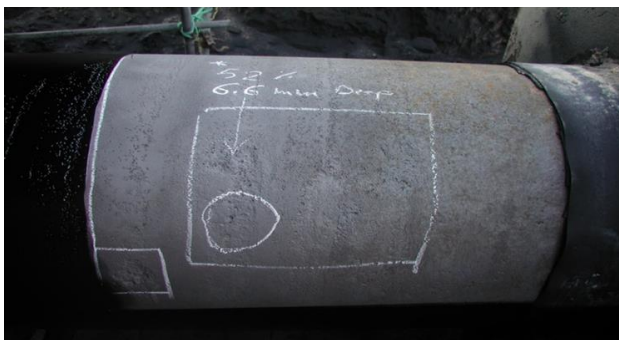
Figure 4- Pitting Corrosion, Defect Location determined by Rosen Smart Pig [1] [2]

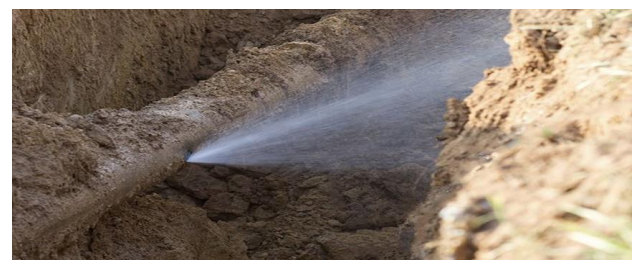
Figure 7: Pipe section leak caused by Stress Corrosion Cracking [1].

Split clamps are repair fittings commonly used for temporary repairs on both onshore and subsea pipelines. However, in this case, the clamp was modified and confirmed as a permanent repair solution. By integrating the clamp as a permanent part of the pipeline, future rework was avoided, effectively making the clamp an integral component of the system. These clamps are designed to seal leaks caused by corrosion or damage. Once fully torqued onto the pipeline, the clamp can be welded to provide a long-term solution.

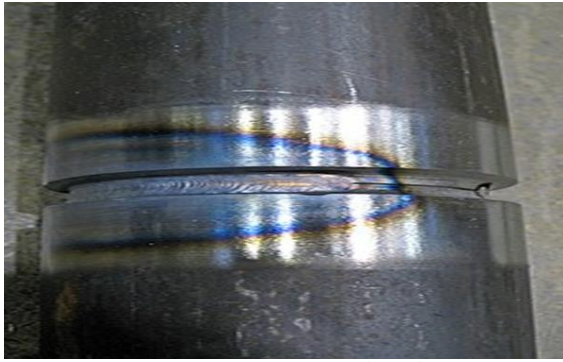
Figure 14 - Oxidation Dark Blue Surface of HAZ [1].

Post-weld heat treatment (PWHT) is recommended to relieve stresses in the HAZ and improve the overall integrity of the repair. PWHT involves heating the repaired area to a specific temperature range (510°C to 650°C) and then cooling it slowly to prevent cracking. This process is particularly important for high-strength low-alloy steels and quenched and tempered steels, which are more prone to hydrogen-induced cracking [4].

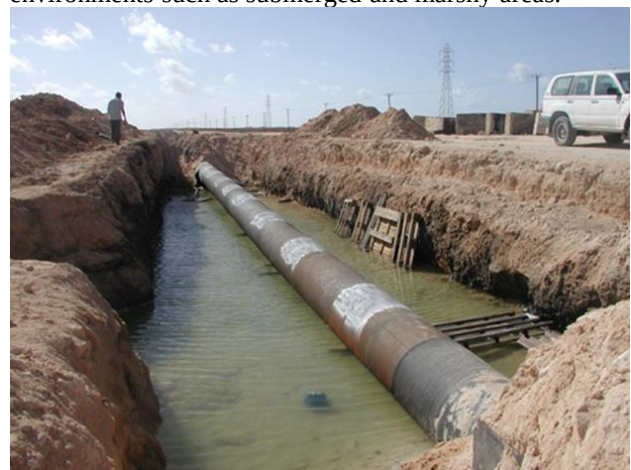
However, significant challenges remain, particularly in sections of the pipeline that are submerged in the sebkha area and pass below sea level. These underwater sections are exposed to both mechanical stress and temperature fluctuations, which can lead to recurrent cracking. The gas flowing through the pipeline at approximately 49°C (120°F) undergoes sudden cooling, putting additional stress on the metal structure and increasing the likelihood of cracks.

Figure 17: Immersed Pipeline Below sea level (sebkha area) [2].

To prevent future issues, it is strongly recommended to redesign and install an optimized air cooler between the manifold and the main pipeline. This would enhance the cooling process, reducing thermal stress on the pipeline and mitigating the risk of further cracking.
