Investigation into Morphology of Cavitation Erosion-Corrosion Pits on the Surface of Carbon Steel

Abstract — Nano-sized films associated with the ring areas formed around micropits in cavitation erosion experiments were investigated. The corrosion behavior and vibratory cavitation erosion tests of mild carbon steel in 3% NaCl distilled water were carried out. The results showed that the nano-sized films associated with the ring areas formed around micropits in cavitation and free cavitation tests have a similar shape. The study proved that the nano-structure and the ring areas formed around micropits are the result of corrosion effects and not as a result of thermal effects related to the collapse of the bubbles.

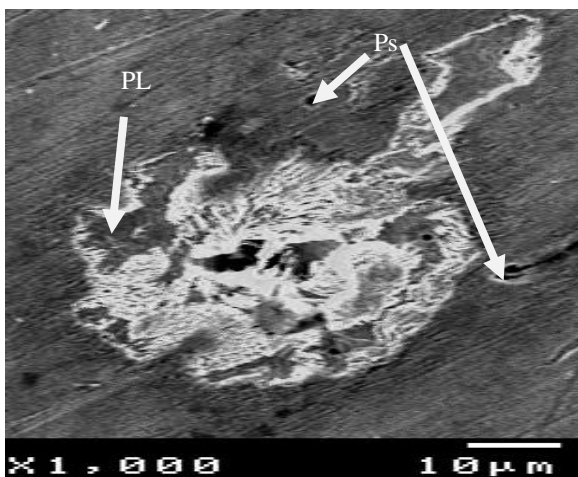
Figure 7 High magnification for the pits (P) showing the pitting interactions

For the spatial interaction amongst localized corrosion sites will be highlighted from magnified photos shown in Figure 7. This interaction seems in the form of satellite pits, labeled P_s , that tend to form patterns around larger primary pits, labeled P_L . This is in agreement with that reported in the literature [40, 51]. Pitting is considered to be autocatalytic in nature; once a pit starts to grow, the conditions developed are such that further pit growth is promoted as reported by Frankel [53]. This can be explained [52], when a pit begins to form, the local environment changes. Concentration changes in solution occur when metal cations enter solution and hydrolyze, bringing about an increase in both the local chloride concentration and local acidity. The environment in this way becomes more aggressive. Solution concentration and potential gradients develop that can affect pitting susceptibility on adjacent surfaces. These factors can also affect nearby oxide films and non-metallic inclusions to produce more permanent interactions. Taking into account these local changes, pitting can have a significant influence on the susceptibility of adjacent surfaces to localized corrosion. However, the time constant associated with each of these interactive processes differs.

Figure 7 shows another important feature, is a formation of dense nano-sized films around pit. For more clarity some of pits with nanostructure are magnified as shown in Figures 8 and 9.
